Manhole Inspection Summary

Manhole # S09A1_003MH

Insp Date: **5/14/08 12:31 PM**

Location Address: **3502 Benson Av**

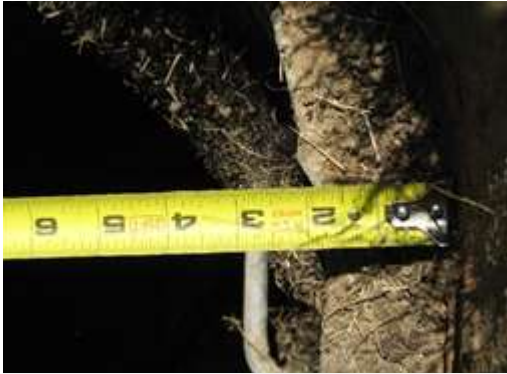
Defect 1

Frame Offset: **2** (in.) Condition: ☒ Sound ☐ Cracked ☐ Leaks

View of Mh

offset 2 inches

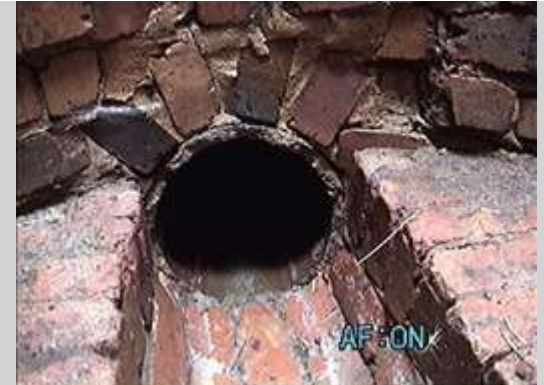
12 O'Clock Outflow

8 in. Circular Gravity Sewer
Pipe Out @ 12 O'Clock

Pipe Height: **8.4** (in.) Rod and Bar (Angled)
Pipe Material: **Clay** ☐ Pipe Lined
Invert Depth: **9.09** (ft.) Flow Characteristics: **None**
Deposits: ☒ None ☐ Mud ☐ Sludge ☐ Debris ☐ Grease
Silt Depth: **0** (in.) Deposits Extent:
Infiltration: **None** Pipe Seal Cond: **Sound**

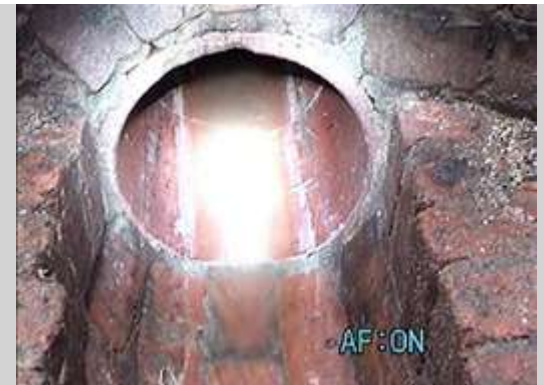
6 O'Clock Inflow

8 in. Circular Gravity Sewer
Pipe In @ 6 O'Clock

Pipe Height: **8.4** (in.) Rod and Bar (Angled)
Pipe Material: **Clay** ☐ Pipe Lined
Invert Depth: **9.07** (ft.) Flow Characteristics: **Slow**
Deposits: ☒ None ☐ Mud ☐ Sludge ☐ Debris ☐ Grease
Silt Depth: **0** (in.) Deposits Extent:
Infiltration: **None** Pipe Seal Cond: **Sound**
